LuK Failure Diagnosis

Guidelines for Evaluating
Clutch System Malfunctions

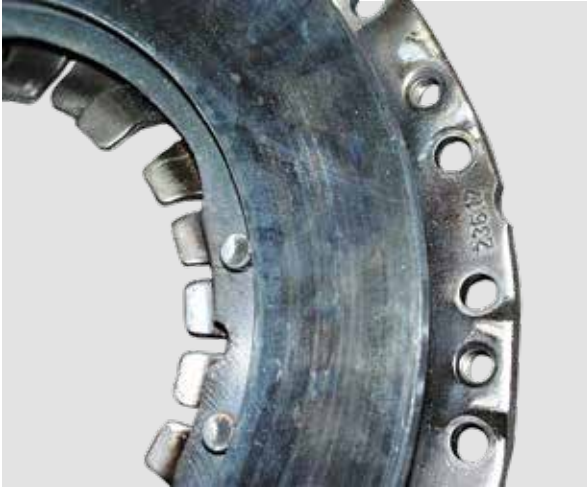
THERMAL LOADING ON THE PRESSURE PLATE IS TOO HIGH

- Oil or grease on the clutch linings
- Play of the release bearing is too low
- Release system is defective
- Operating error, e.g. allowing the clutch to slip for too long

- Rectify the cause
- Replace the clutch kit
- Advise the driver regarding possible operating errors (see page 6)

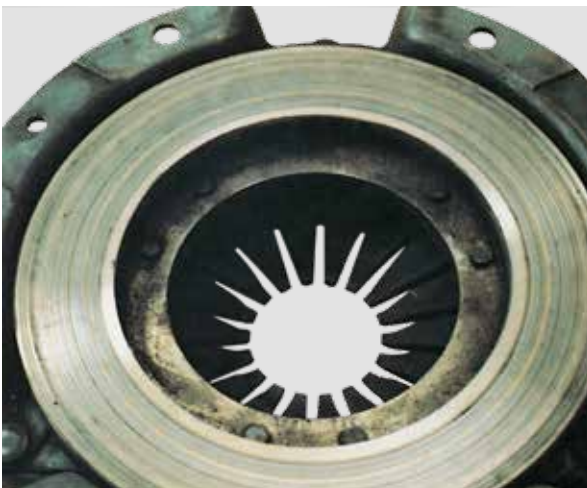
HEAVY SCORING AND TRACES OF OVERHEATING ON THE PRESSURE PLATE

- Clutch has been operated beyond the wear limit
- Play of the release bearing has been set incorrectly
- Release system is defective
- Operating error

- Rectify the cause
- Replace the clutch kit
- Advise the driver regarding possible operating errors (see page 6)

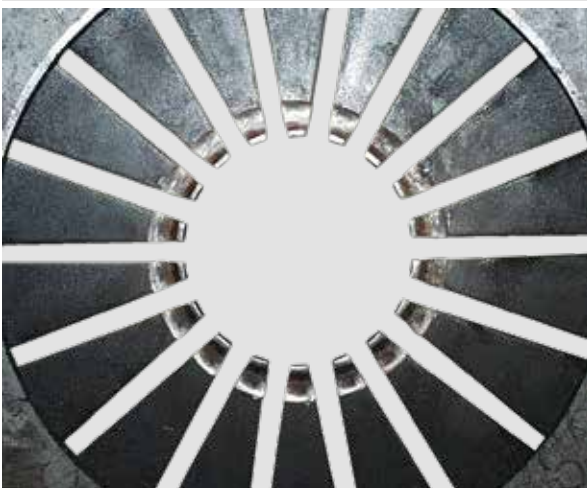
DISK SPRING TIPS HAVE BEEN RUN IN

- Release bearing preload has been too low
- Release bearing is stiff
- Hydraulic release system is defective

- Increased wear on the disk spring tips
- Malfunctions of the clutch

- Replace clutch, release bearing and guiding sleeve
- Check the release system, set preload according to specifications of vehicle manufactures if necessary

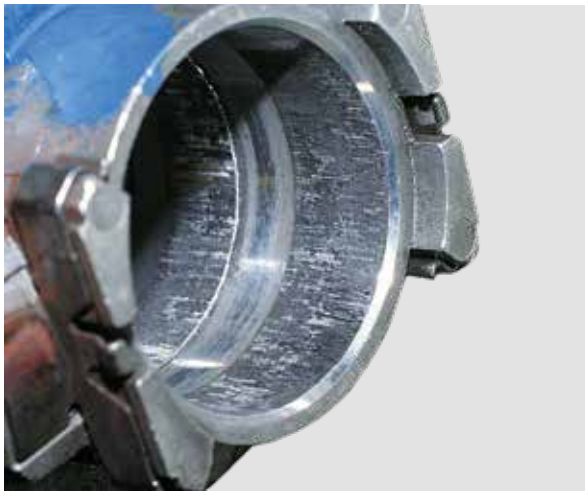
TRACKS IN THE RELEASE BEARING SLEEVE

- Release bearing has been incorrectly or insufficiently greased, or not greased at all
- Sliding bush is worn
- Release bearing is stiff

- Replace the sliding bush and the release bearing
- Grease according to the vehicle manufacturer's specifications if necessary
- Replace the clutch kit

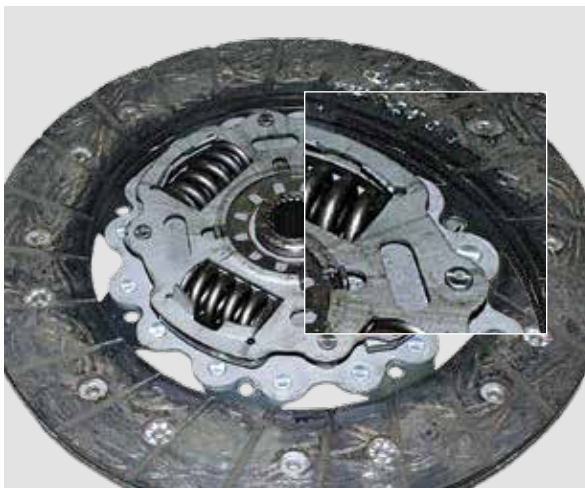
FRICTION LINING ON THE INNER RING IS OILY/ GREASY

- Radial shaft seals or other components in the engine/transmission are leaking
- Hydraulic release system is defective
- Hub profile over-greased

- Lubricant is transferred via the centrifugal force from the hub profile onto the clutch lining, leading to fluctuation of the frictional coefficient, which causes the clutch to grab or slip

- Replace the clutch kit
- Follow the greasing guidelines for the hub
- Check the release system
- Check the engine and transmission for leaks

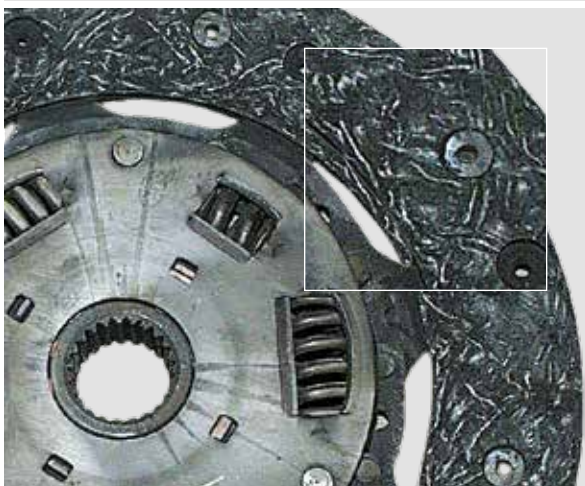
CLUTCH LINING IS CARBONIZED

- Radial shaft seals or other components in the engine/transmission are leaking
- Hydraulic release system is defective
- Hub profile over-greased
- Decrease in the frictional coefficient due to overheating (e.g. by allowing the clutch to slip for too long)

- Seal the leaks
- Replace the clutch kit (grease the hub profile correctly)
- Advise the driver regarding possible operating errors (see page 6)

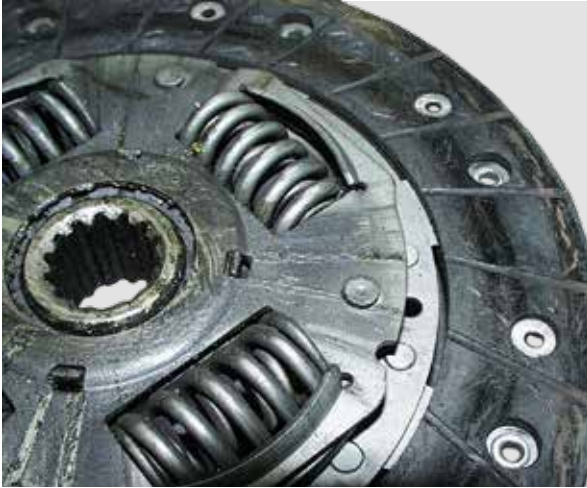
CLUTCH LINING IS OILY

- Radial shaft seals or other components in the engine/transmission are leaking
- Hydraulic release system is defective
- Hub profile over-greased

- Replace the rotary shaft seals
- Clean the clutch cover
- Replace the clutch kit

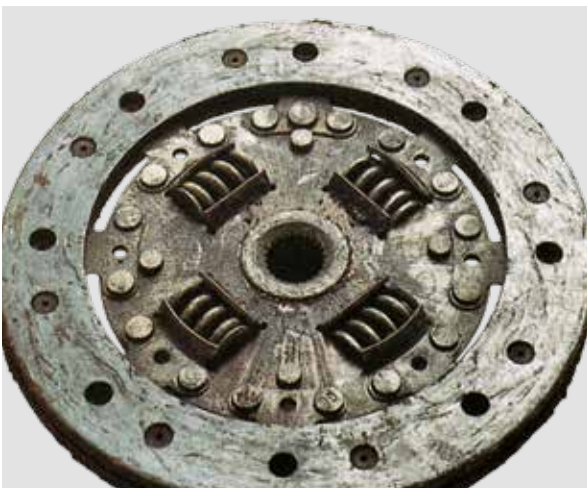
CLUTCH LININGS ARE COVERED IN EXCESS GREASE

- Hub of the clutch disk has not been greased correctly
- Too much lubricant has been used

- Clean the clutch cover
- Clean the transmission input shaft
- Replace the clutch kit
- Grease the hub correctly

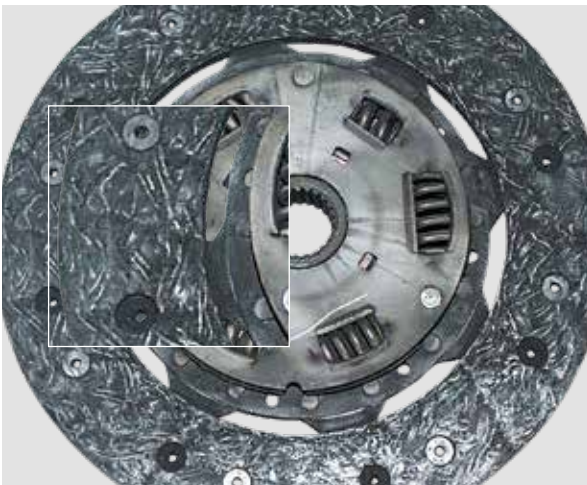
CLUTCH LINING IS WORN DOWN TO THE RIVETS

- Normal wear
- Vehicle was still driven despite the clutch slipping
- Driving errors (in the event of a premature malfunction)
- Incorrect clutch
- Release system is defective

- Replace the clutch kit
- Check the release system and repair if necessary
- Advise the driver regarding possible operating errors (see page 6)

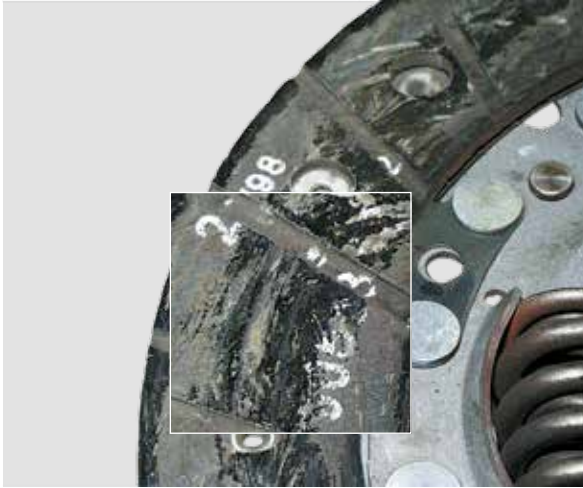
LINING SCORED ON THE FLYWHEEL SIDE

- Wear on the friction surface of the flywheel was not noticed when the clutch was replaced
- Rigid flywheel has not been reworked or the DMF has not been replaced

- Replace the clutch kit
- Rework the friction surface or replace the flywheel (in the case of a rigid flywheel)
- Do not rework the friction surface of the DMF! If worn, replace the component

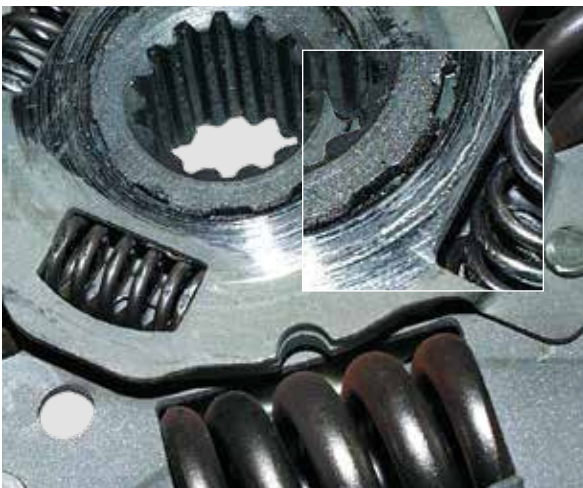
CONTACT TRACKS ON THE HUB OF THE CLUTCH DISK

- Assembly error (installation direction of the clutch disk is incorrect)
- Incorrect clutch disk has been installed

- Replace the clutch kit
- Note the correct installation position of the clutch disk

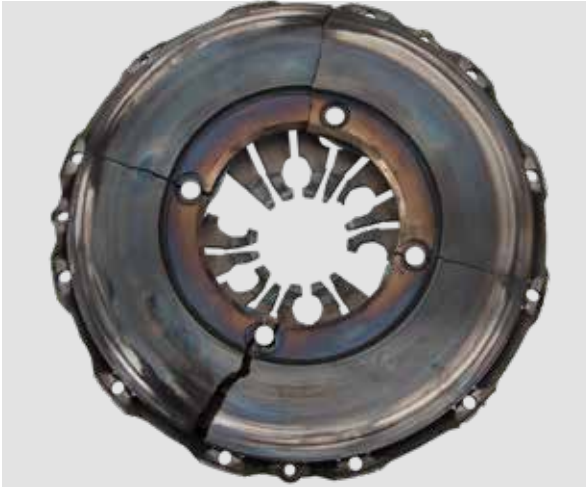
PRESSURE PLATE HAS OVERHEATED/BROKEN

- Damage caused by force and operating errors
- Driving with an excessive load

- Replace the clutch kit
- Advise the driver regarding operating errors

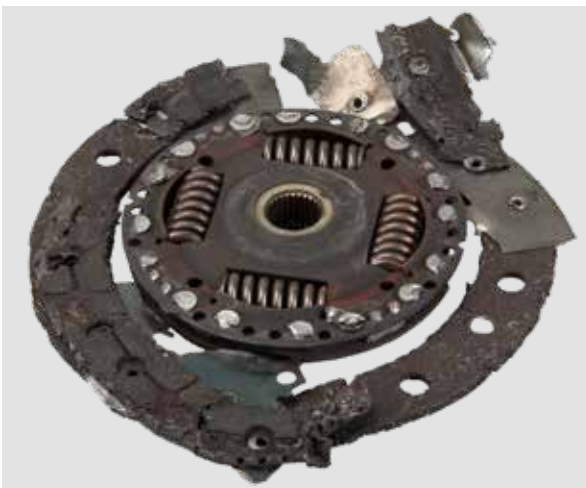
CLUTCH DISK HAS BURST

- Damage caused by force and operating errors
- Speed of the clutch disk was higher than the burst speed of the lining. This condition occurs when the speed of the vehicle exceeds the maximum permissible speed of the gear when the gear is engaged and the clutch is actuated continuously

- Replace the clutch kit
- Advise the driver regarding operating errors

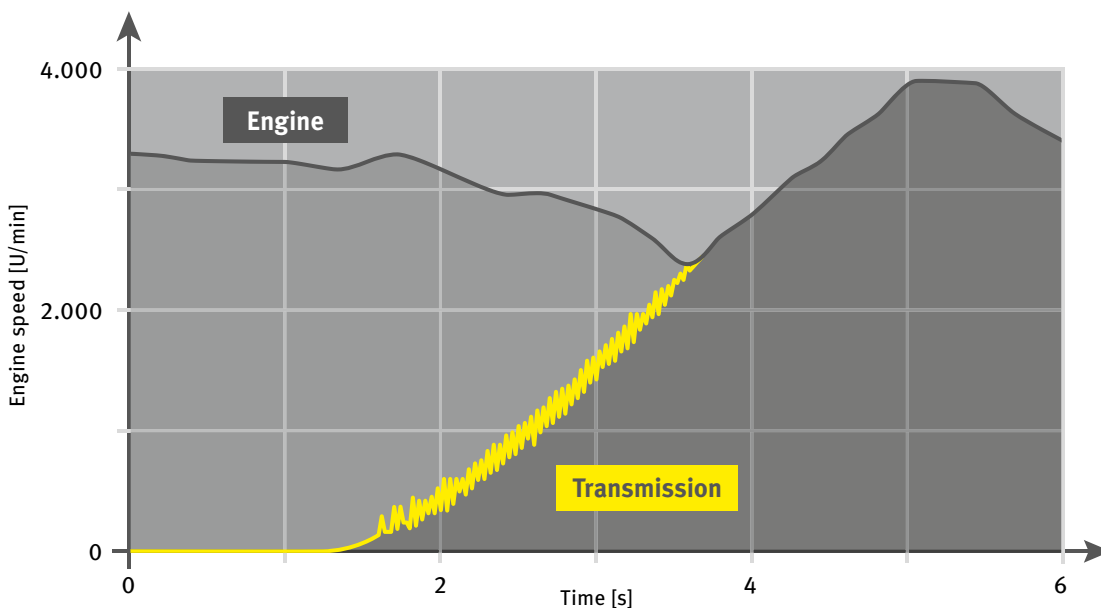
When the clutch grabs during a start-up procedure, vibrations occur in the form of periodic fluctuations in the rpm, which generally last until the two speeds have reached the same level. These deviations are perceived during every start-up procedure as irritating vehicle vibrations.

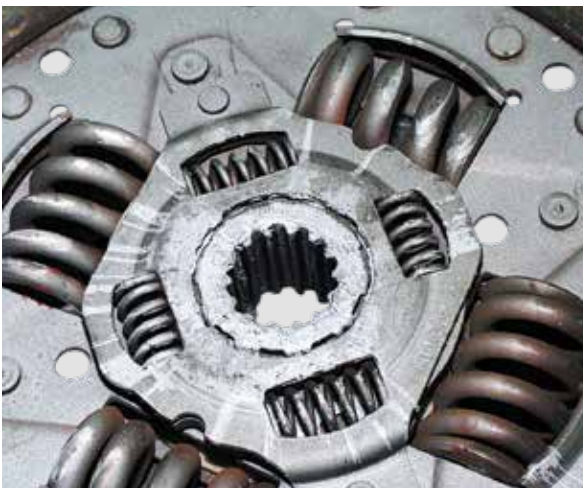
HUB PROFILE HAS BEEN INCORRECTLY GREASED

- Unsuitable or excessive grease has been applied

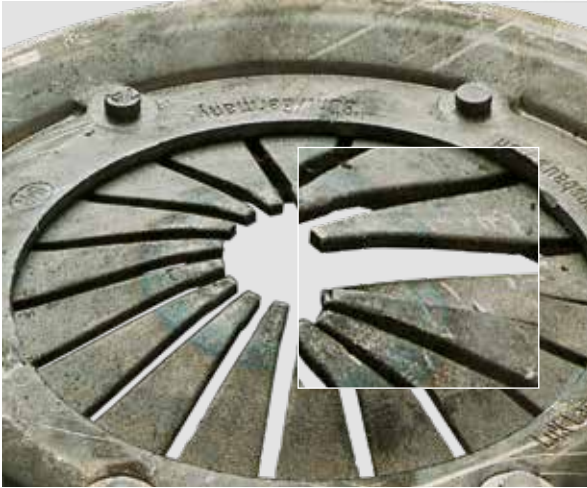
DISK SPRING TIPS ARE BENT

- Assembly error: Disk spring tips have been bent during installation of the transmission

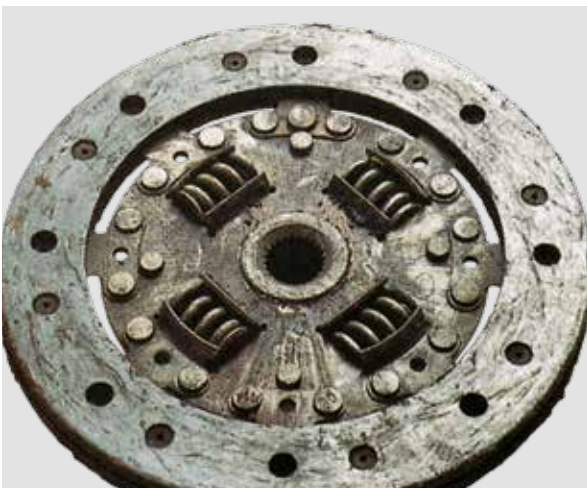
CLUTCH LINING IS OILY

- Assembly error (incorrect and/or excessive lubricant applied)
- Engine or transmission is leaking

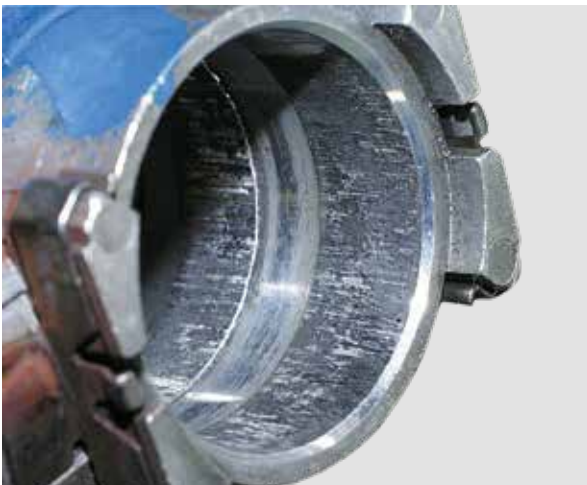
RELEASE BEARING IS STIFF,
SIGNS OF WEAR ARE VISIBLE

- Incorrectly or insufficiently greased
- Sliding bush is worn and was not replaced when the clutch was replaced

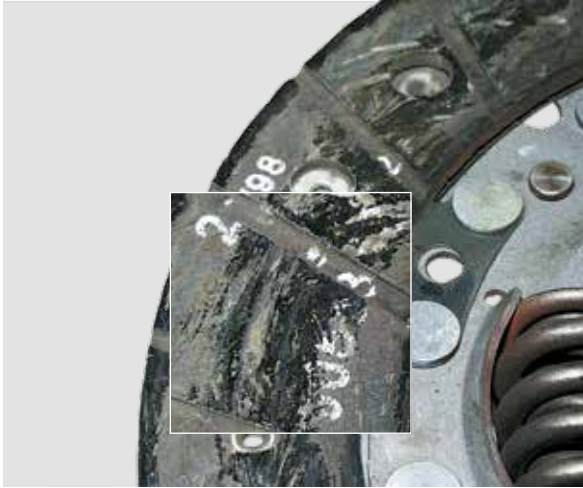
LINING SCORED ON THE FLYWHEEL SIDE

- Wear on the friction surface of the flywheel was not noticed when the clutch was replaced
- Rigid flywheel has not been reworked or the DMF has not been replaced

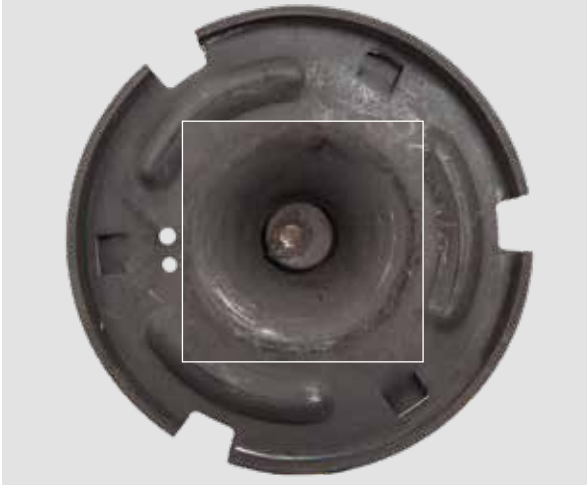
OFF-CENTER CONTACT TRACK IN THE RELEASE SPRING (VW CLUTCH SYSTEM)

- Release bearing on the push rod is deformed
- Guide bush on the push rod is worn

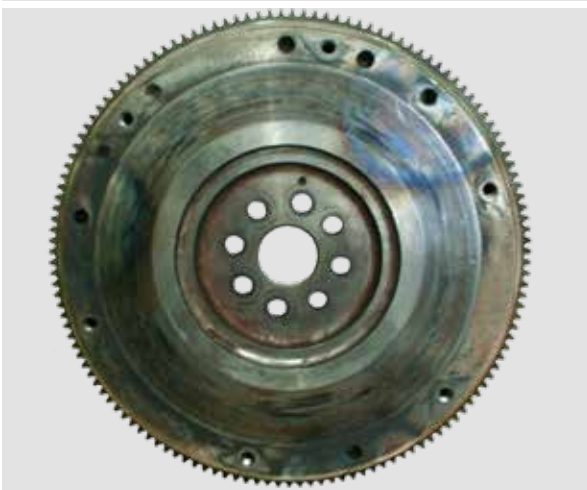
FRICTION SURFACE ON THE FLYWHEEL IS WORN

- High temperatures, e.g. due to operating errors or a defect in the release system
- Friction surface on the flywheel is worn (rigid design) and was not reworked when the clutch was replaced
- DMF is worn and has not been replaced

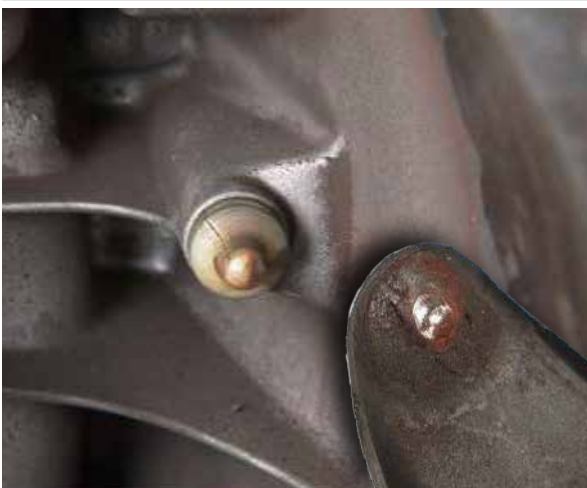
RELEASE FORK AND/OR BALL PIN IS WORN

- Normal wear

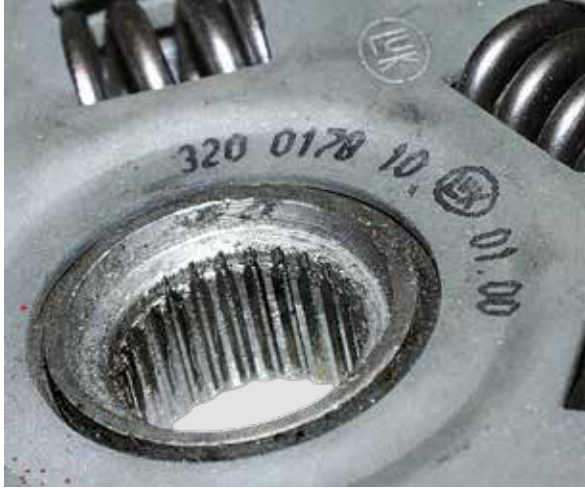
HUB PROFILE IS DAMAGED

- Transmission input shaft has been forced into the hub
- Clutch disk was not centered during installation
- Incorrect clutch has been installed

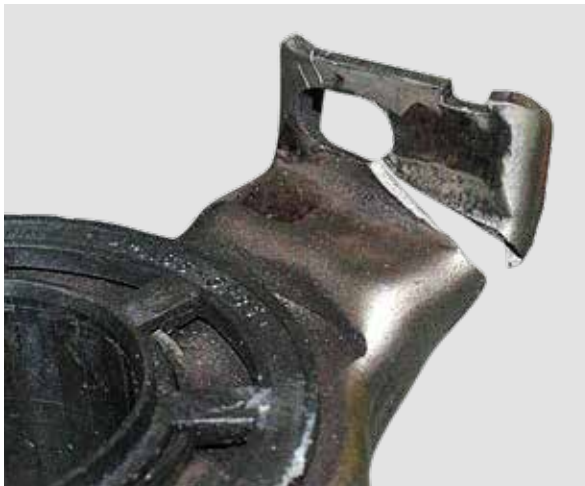
RELEASE FORK MOUNT ON THE RELEASE BEARING IS BROKEN

- Fork and release bearing not installed correctly
- Incorrect release bearing installed

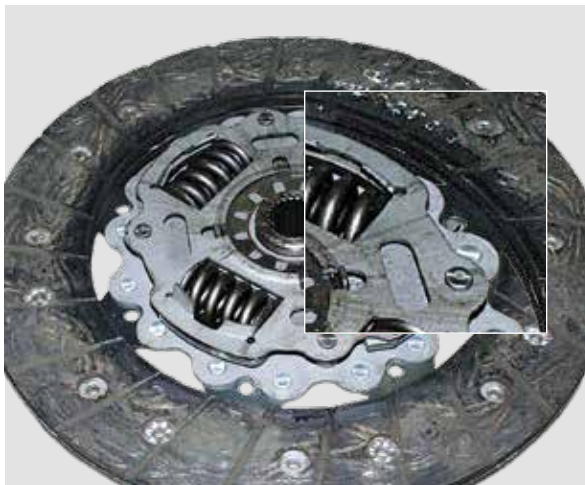
FRICTION LINING ON THE INNER RING IS OILY/ GREASY

- Radial shaft seals or other components in the engine/transmission are leaking
- Hydraulic release system is defective
- Hub profile over-greased

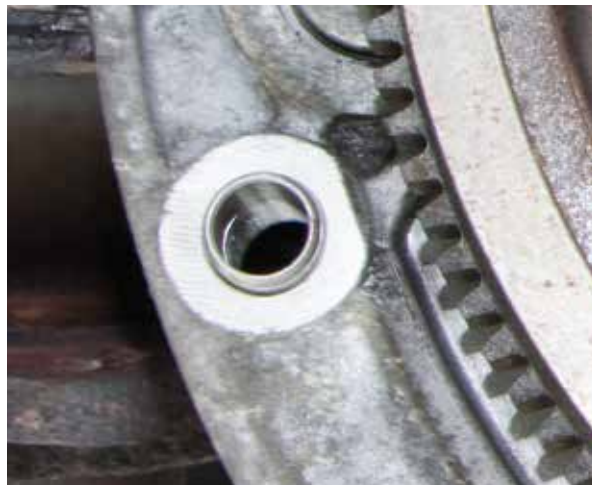
If the centering sleeve is missing or deformed, this can cause problems when disengaging the clutch.

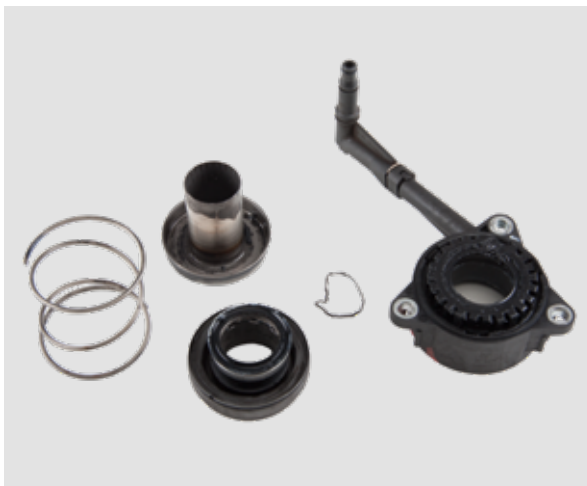
MECHANICAL DAMAGE TO THE CSC

- Sliding bush of the CSC has rotated and worked loose from the housing due to the axial clearance of the transmission input shaft being too high

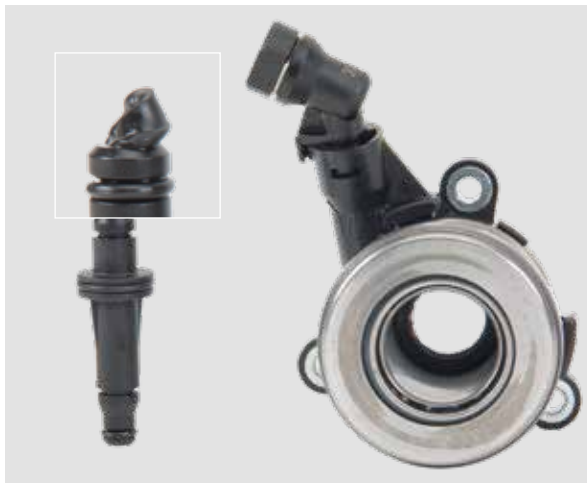
CSC BURSTS DIRECTLY AFTER INSTALLATION

- When the new CSC was installed, the old seal was not removed from the cable connection. After the installation, the old seal acts as a valve and prevents pressure from being released from the CSC. Once the clutch has been actuated a few times, the pressure increases so much that the CSC bursts

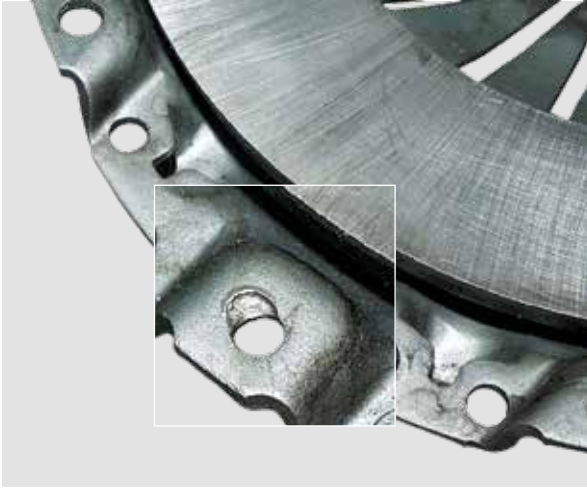
CLUTCH COVER IS DEFORMED

- Centering pin in the flywheel was not accounted for when installing the pressure plate

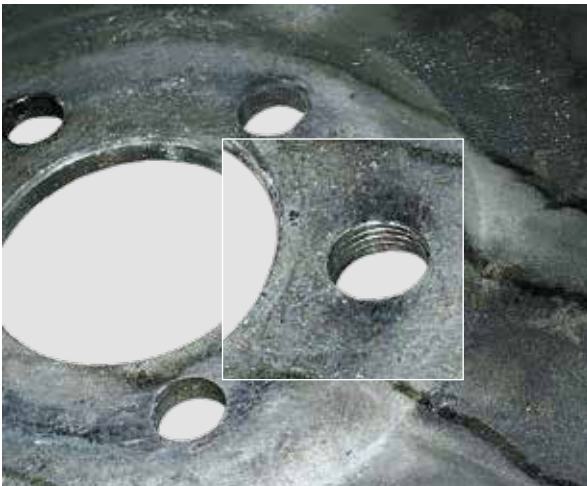
THREAD IN THE SCREW HOLES IS WORN, TANGENTIAL LEAF SPRING IS BROKEN (VW)

- No securing agent used to fix the clutch screws in place
- Reinforcing panel not installed between the clutch screws and the clutch cover
- Screws have been tightened to the incorrect torque

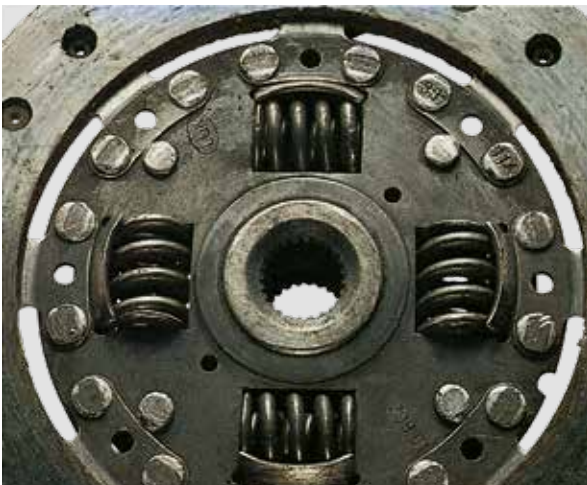
CONTACT TRACKS ON THE RIVET HEADS OF THE SEGMENT RIVETING (VW)

- Snap ring on the pressure plate has been installed incorrectly
- Unsuitable snap ring has been installed

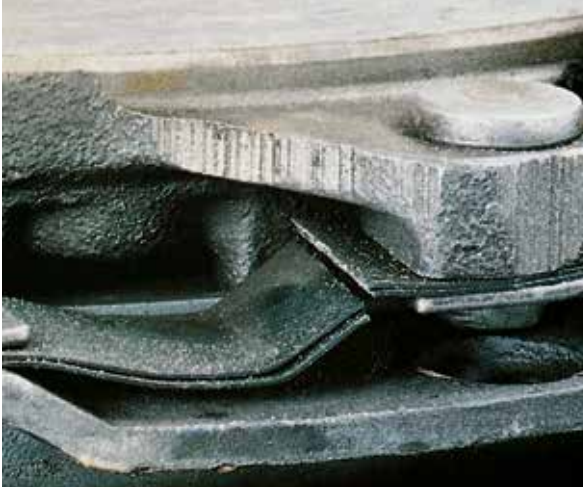
TANGENTIAL LEAF SPRING IS BROKEN

- Play within the powertrain, e.g. a dislodged flex disk
- Operating errors, e.g. towing in first or second gear, shifting error
- Incorrect clutch has been installed

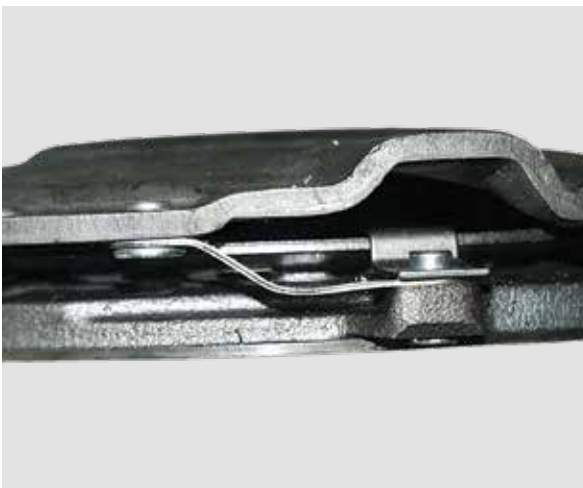
TANGENTIAL LEAF SPRING IS BENT

- Play within the powertrain, e.g. a dislodged flex disk
- Operating errors, e.g. towing in first or second gear, shifting error
- Improper bearing arrangement for the clutch
- Clutch dropped before or during assembly
- Incorrect detent when screwing on the clutch

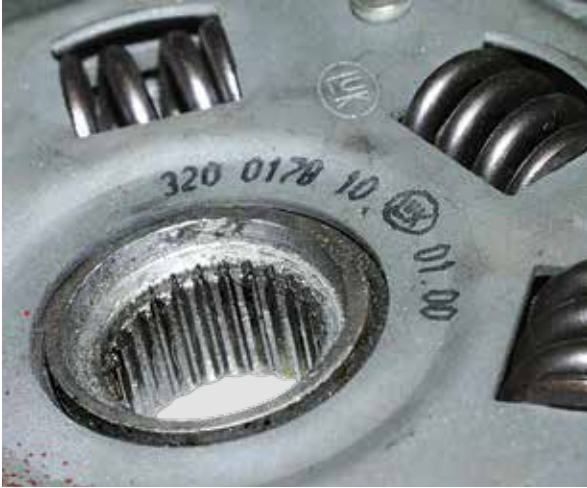
HUB PROFILE IS DAMAGED

- Transmission input shaft has been forced into the hub
- Clutch disk was not centered during installation
- Incorrect clutch has been installed

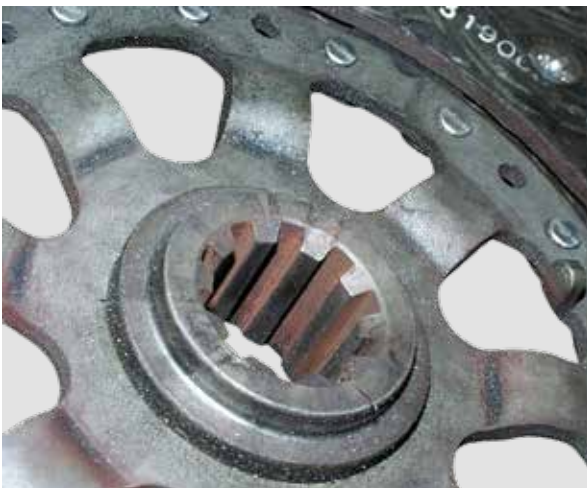
FRETTING CORROSION (RUST FILM) ON THE HUB PROFILE

- Transmission input shaft or hub profile not greased at all or greased using an unsuitable lubricant

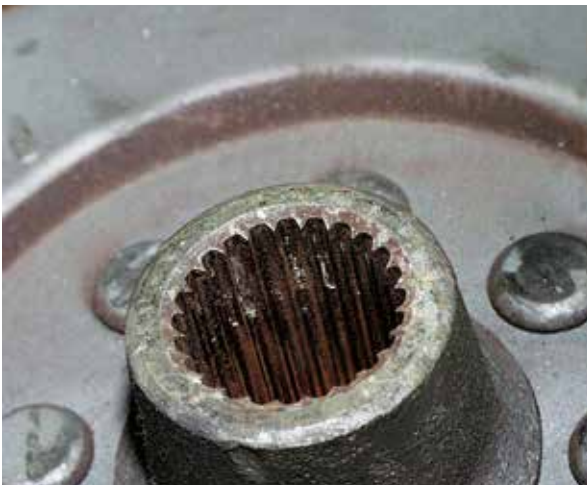
HUB PROFILE IS DEFORMED, TAPERED GEARING PROFILE

- Pilot bearing is defective
- Angular displacement between the engine and the transmission
- No centering sleeve or the centering sleeve is damaged

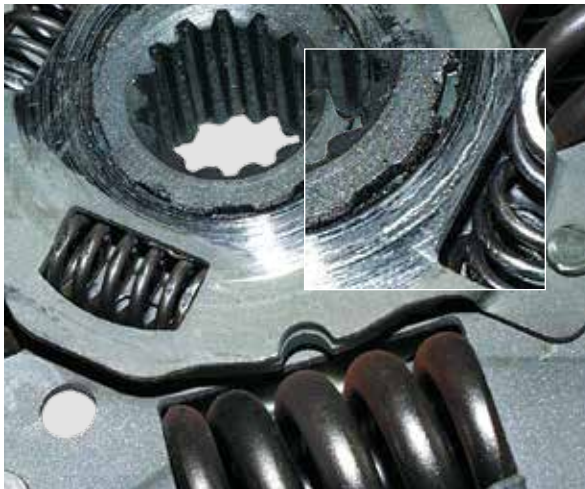
CONTACT TRACKS ON THE FIRST STAGE DAMPER OF THE CLUTCH DISK

- Installation position for the clutch disk is incorrect
- Incorrect clutch disk has been installed

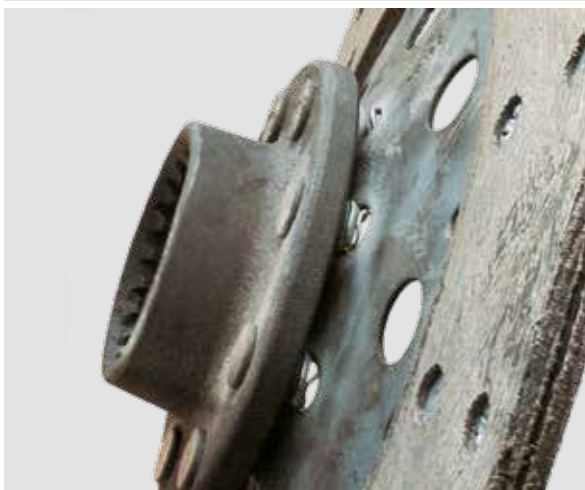
CLUTCH DISK HAS BECOME SAUCER-SHAPED

- Clutch disk has not been centered and has been deformed by subsequent installation of the transmission

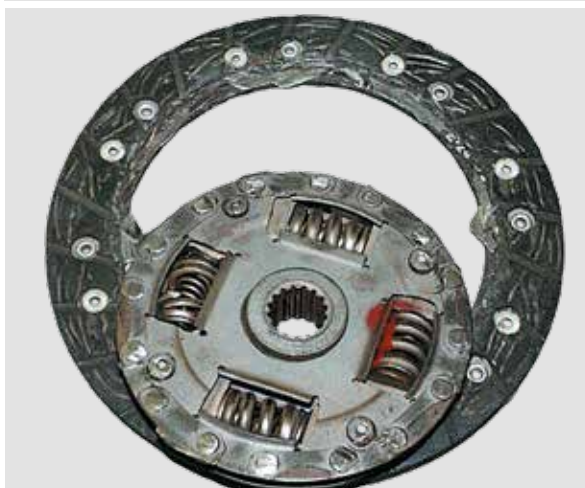
DISC ASSEMBLY IS BROKEN

- Pilot bearing is defective or missing
- Angular or parallel displacement between the engine and transmission
- Transmission has been lowered during installation

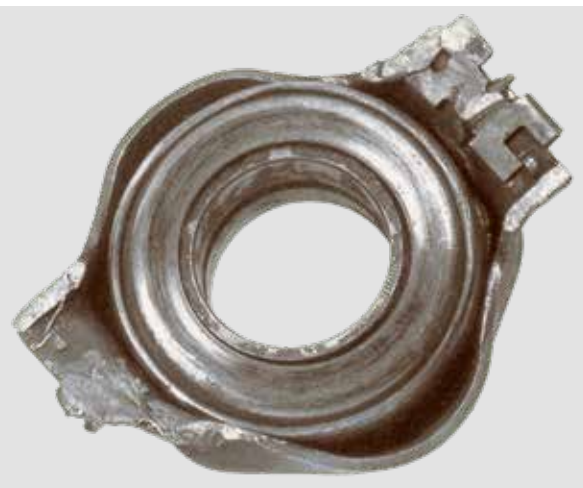
HOUSING OF THE RELEASE BEARING IS DEFORMED

- Release bearing is blocked on the guiding sleeve
- Bearing arrangement on the release shaft is worn

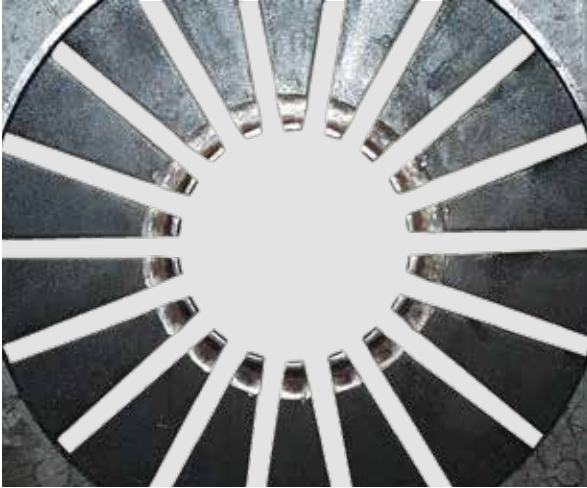
DISK SPRING TIPS HAVE BEEN RUN IN

- Default setting of the release fork is incorrect (Opel)
- Preload on the release bearing is too low

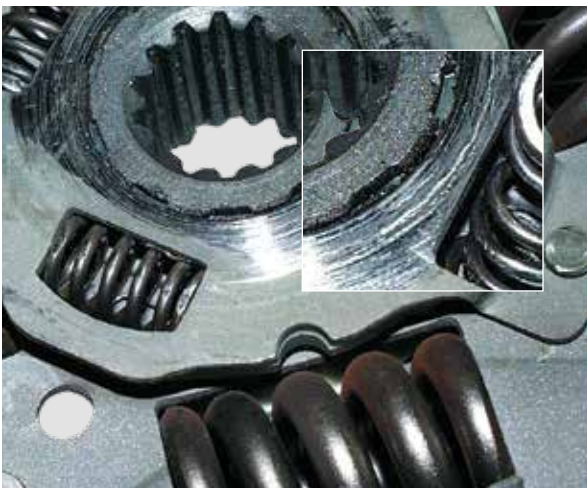
CONTACT TRACKS ON THE FIRST STAGE DAMPER

- Default setting of the release fork is incorrect (Opel)
- Preload on the release bearing is too high

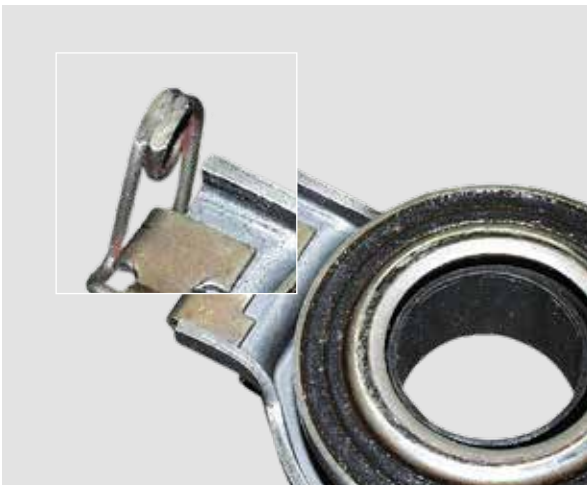
CONTACT TRACKS ON THE FORMED SPRING

- Default setting of the release fork is incorrect (Opel)
- Preload on the release bearing is too high

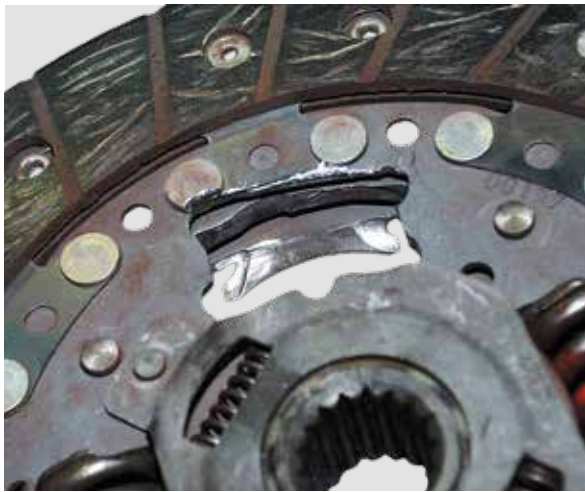
SPRING WINDOW IS WORN

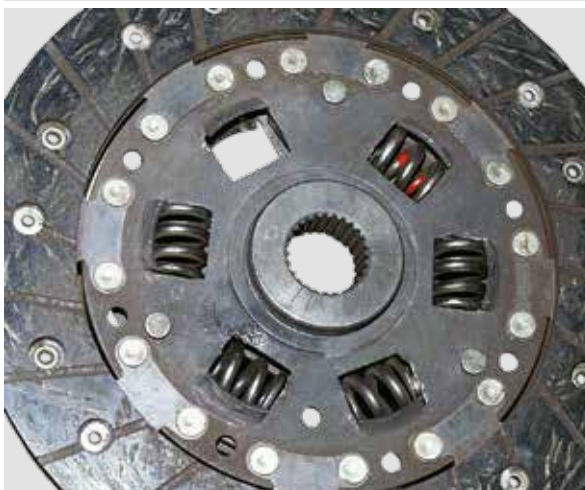
TORSION SPRING IS BROKEN

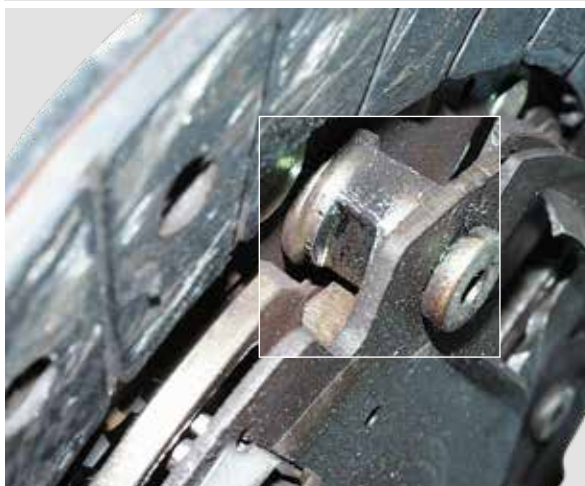
STOP PIN IN THE TORSIONAL DAMPER IS WORN

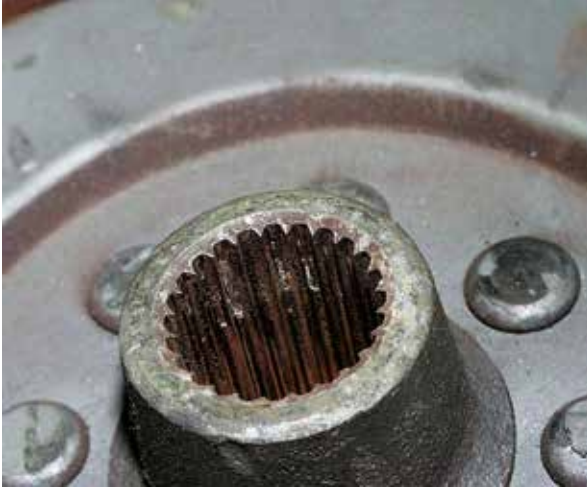
HUB PROFILE IS DEFORMED, TAPERED GEARING PROFILE TORSIONAL DAMPER IS DESTROYED

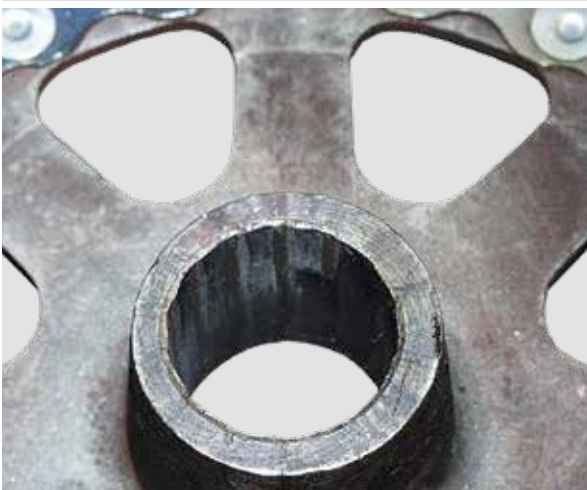
HUB PROFILE IS COMPLETELY MISSING

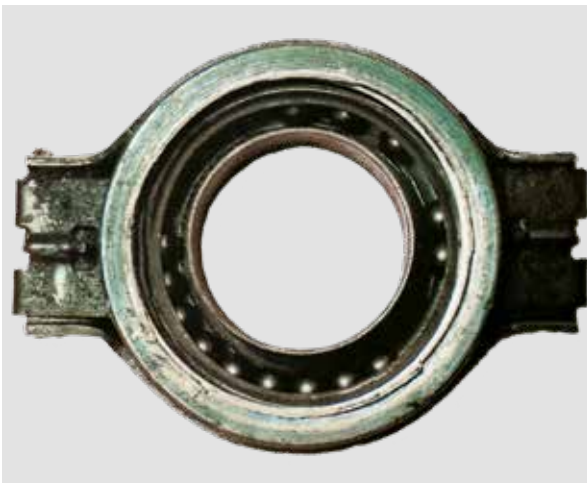
CONTACT BUSHING AND BALL BEARING ARE DESTROYED

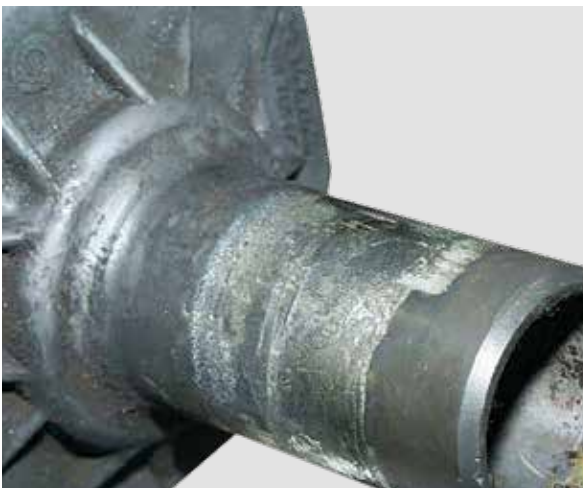
SIGNS OF WEAR VISIBLE ON THE GUIDING SLEEVE

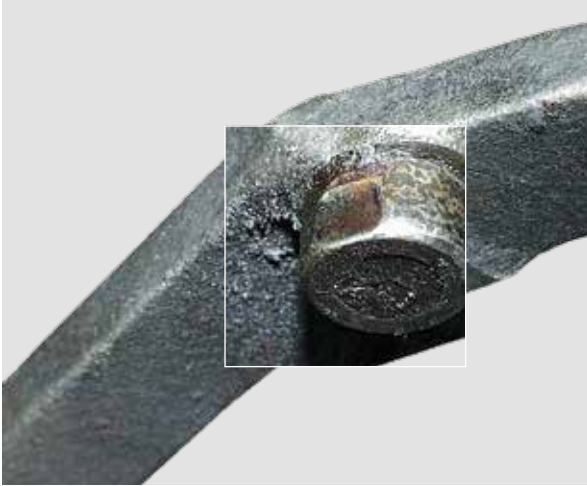
RELEASE BEARING SEATING ON THE RELEASE FORK HAS BEEN RUN IN

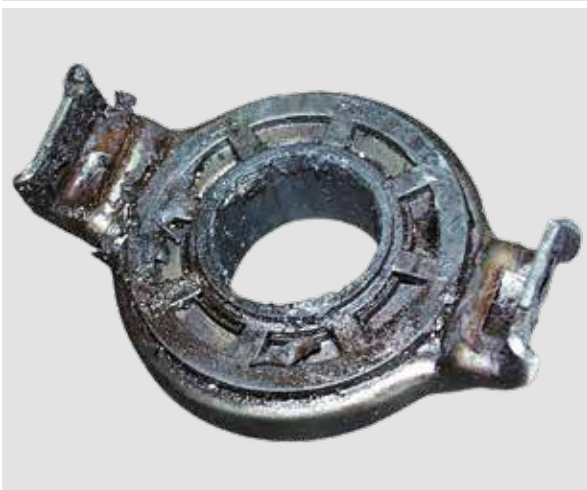
RELEASE BEARING SEATING IS WORN

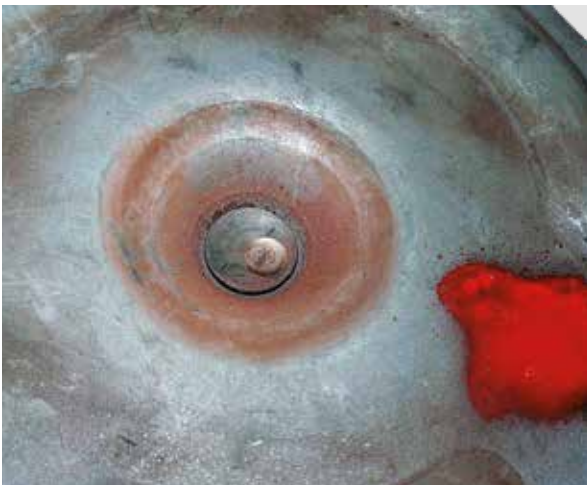
OFF-CENTER CONTACT TRACK IN THE RELEASE SPRING (VW CLUTCH SYSTEM)

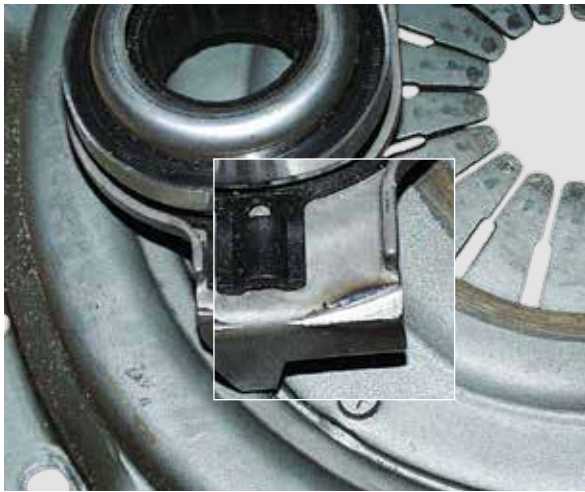
CONTACT TRACKS ON THE CLUTCH COVER AND
RELEASE BEARING

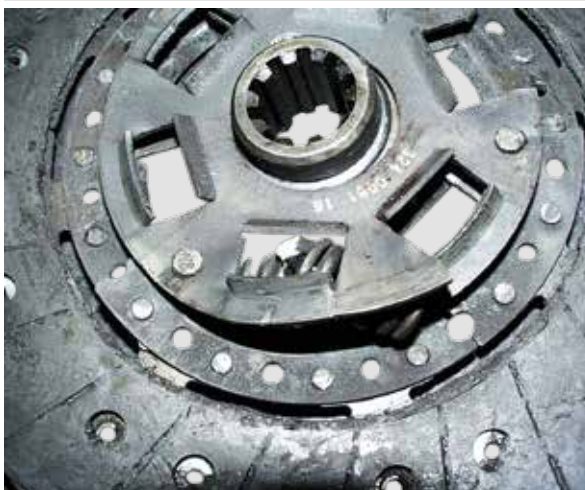
TORSIONAL DAMPER IS BROKEN

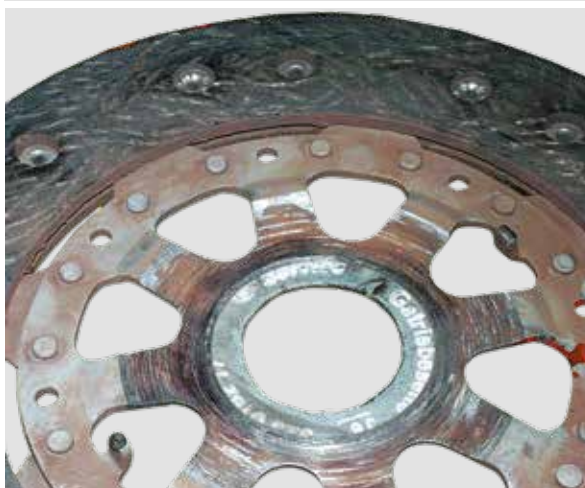
HUB OF THE CLUTCH DISK IS BROKEN

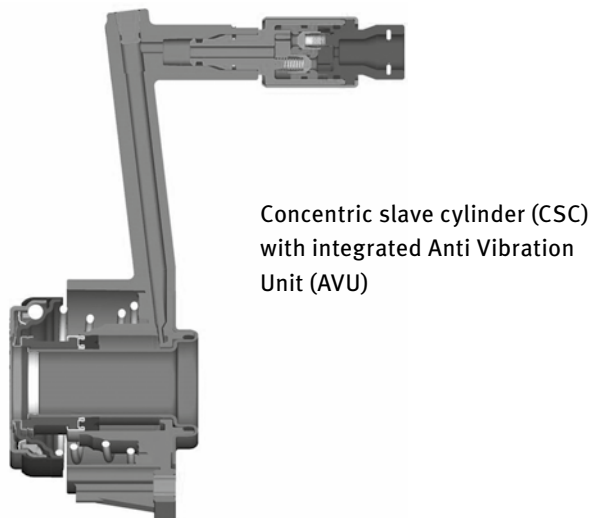
Function of an AVU

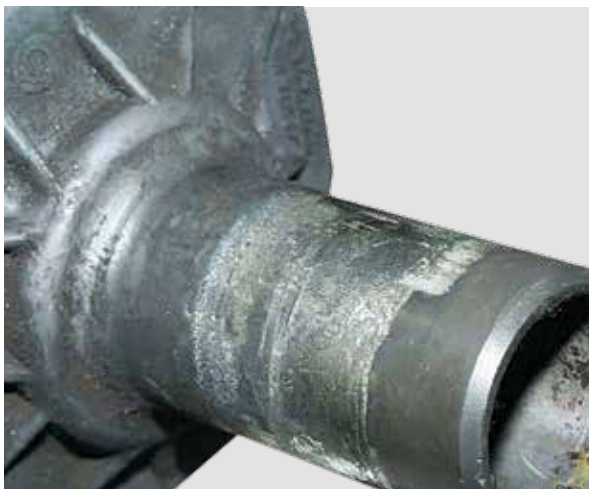
CONTACT TRACKS ON THE GUIDING SLEEVE

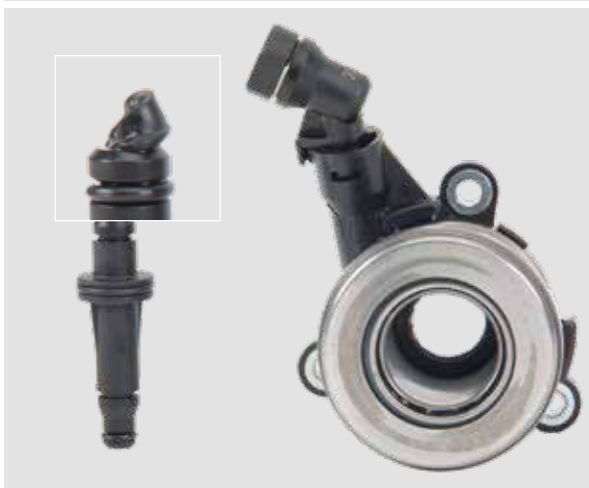
CSC BURSTS DIRECTLY AFTER INSTALLATION

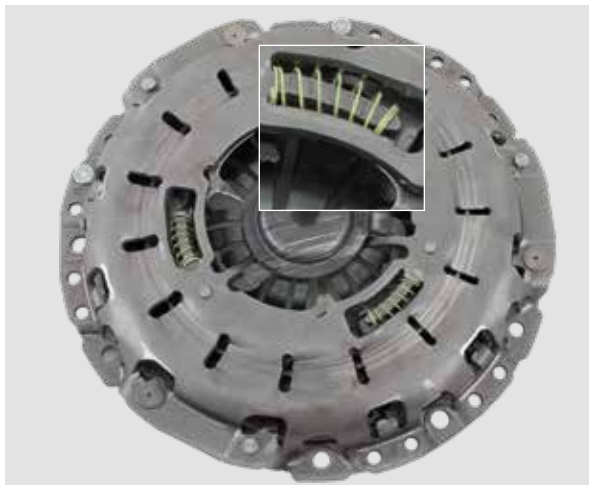
NEW SAC IS ALREADY COMPLETELY ADJUSTED

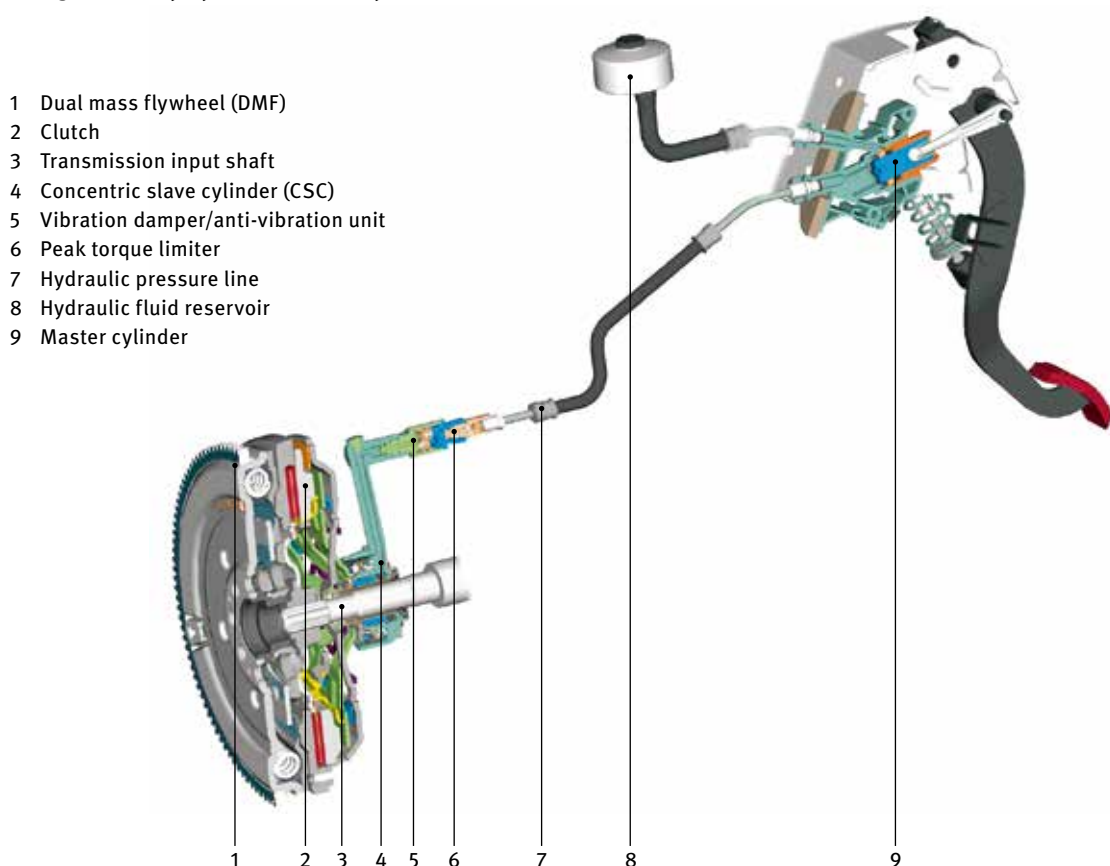
Design of a fully hydraulic clutch system

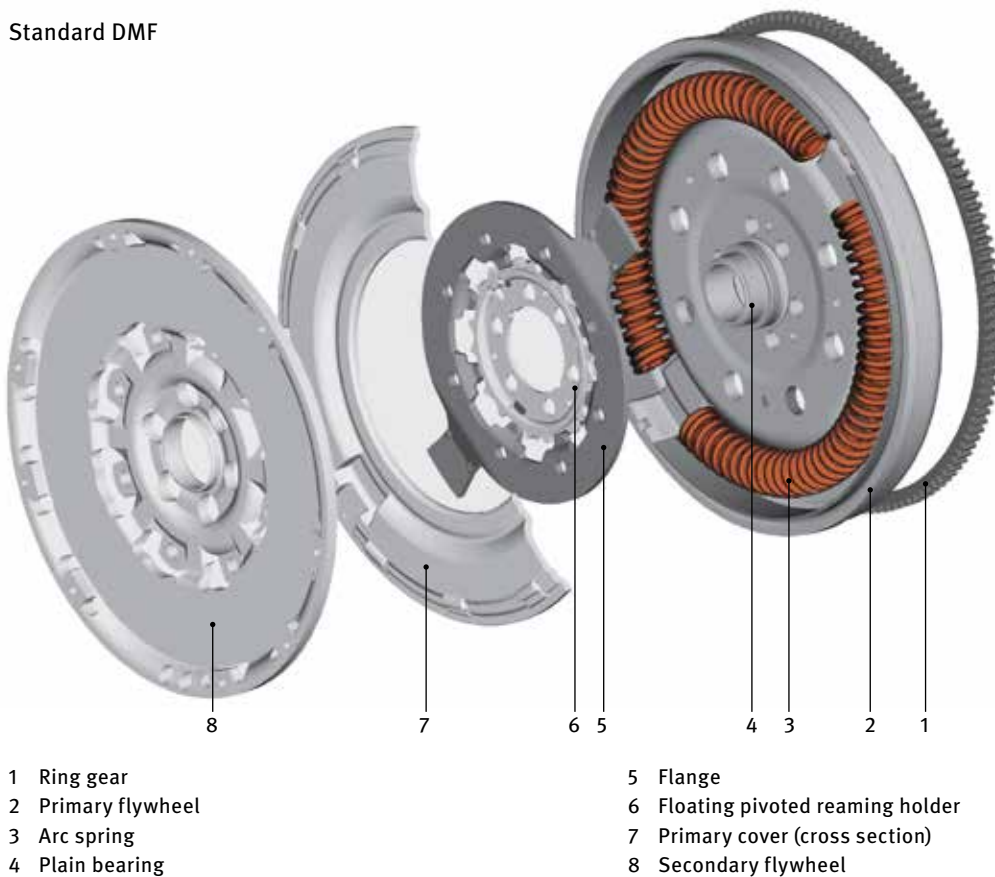
Standard DMF

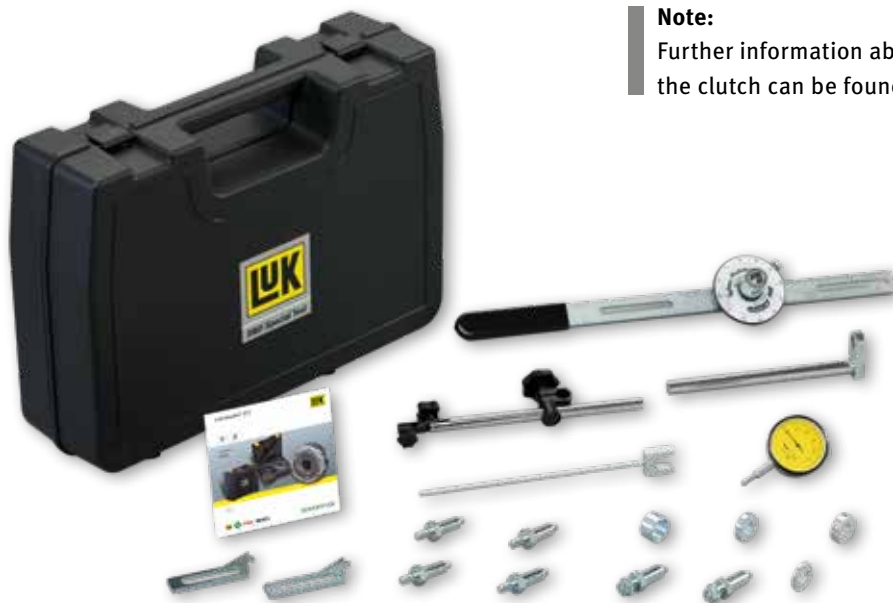
The LuK RepSet DMF inspection tool, part no. 400 0080 10

If the holes are offset in relation to the screws, the DMF could already be damaged. If this is the case, an in-depth inspection using the LuK special tool (part no. 400 0080 10) is recommended.
